# FRC capsizes

FRC capsizes during bird change &  
*MOB* during tail buoy deployment

# FRC Capsize during bird recovery

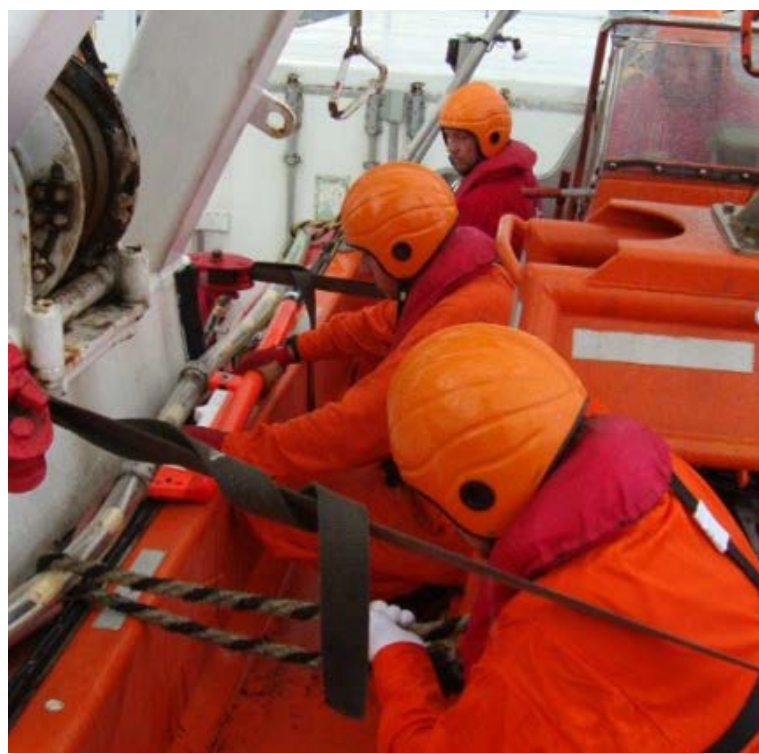
## FRC Capsize during bird recovery

During bird recovery two ropes are used to lift and hold the streamer while the bird is changed.

- Front rope is let go while aft rope is *stuck*.
- Attempt to cut partly fails.
- The vessel is shortly after upside down, but the detached rope breaks.

- Insufficient/ inadequate procedure in place resulting in confusion or assumption.
- Failure to enforce procedures by management.
- Failure to carry out a procedure i.e. no JSA was devised for this task to identify possible risks and mitigations.
- A fault in the design and use of equipment.
- Poor management of subcontractor.

- Review of all related RAs and procedures.
- Bird changes without aft rope.
- Ensure that required PLB and VHF are part of PTW.
- Extraordinary vessel management meeting with all PCs and Captains, the Chairman and the CEO participating.
- Support vessel coordinator role defined & implemented.
- HSSEQ trianer in buget for 2016.

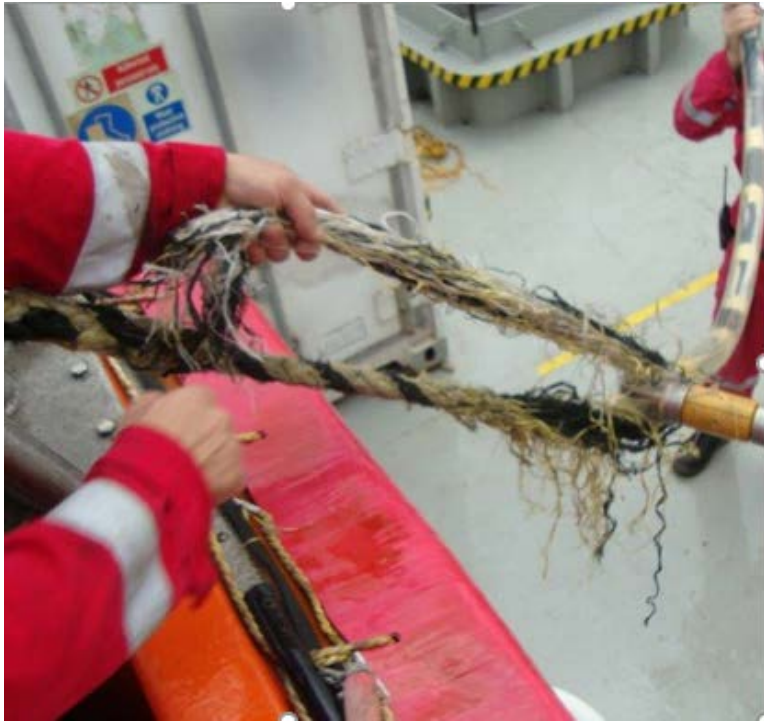
## FRC Capsize during bird recovery

### Four crewmembers in the water, none injured:

- Support vessel not near by.
- Self righting fails.
- No waterproof VHF.
- No PLB.

**Luck is the only remaining barrier.**
